Repairing a Threaded Plastic Extrusion

By Larry Klusza, November, 2022

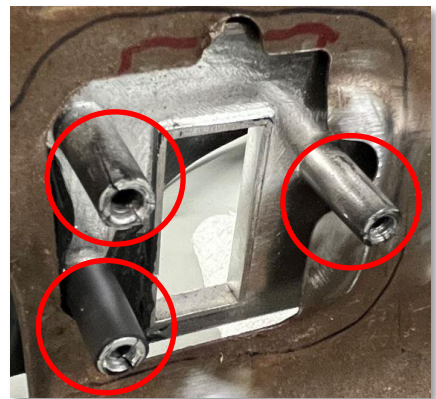
Here, you can see all the cracks in the stalks as well as my initial attempt at a repair. I chose not to use any glue as I didn't want the heat shrink to force the glue down into the threads, which would have potentially caused further issues.

I thought I'd try it on the worst one first. It looks bad but the deeper the threads go, the better they closed. I was able to get more than an acceptable amount of tension on the screw without further stressing the plastic.

One can certainly try to glue the crack and "splint" with some tape while the glue sets, but I found a different method others might find helpful. Basically, I used heat shrink of an appropriate size to close the crack and add support to the stalk. Of course, this trick depends on the diameter of the stalk in question as heat shrink comes in only so many sizes. In my case, I got lucky and it worked well without glue – your experience may differ. Here are some before and after pics:

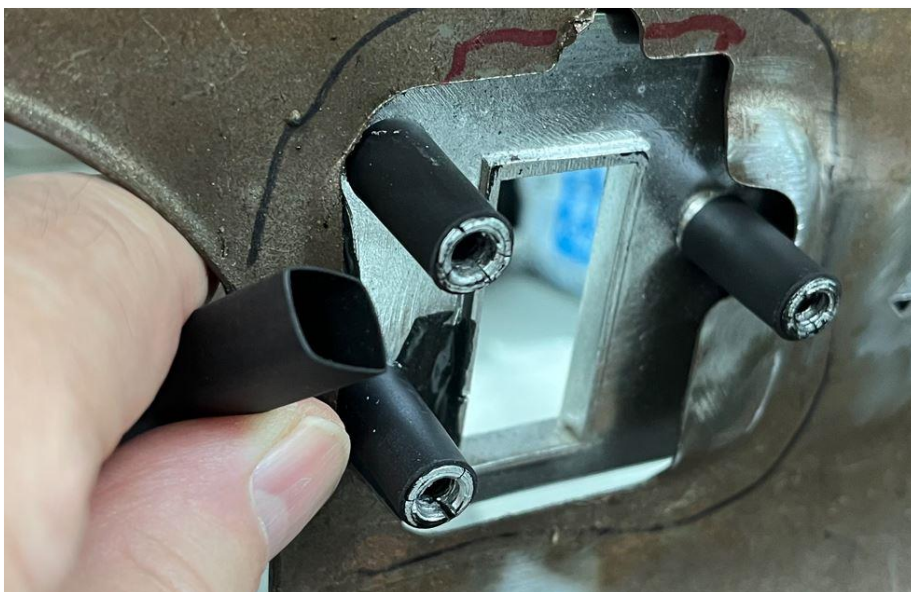
Here is a picture of all three stalks done. You can see how much the cracks closed.

It turns out that the previous owner had the switch misaligned. I had to notch out the areas marked in red to make the switch sit squarely in the hole and on the mounting stalks.

The switch is now securely mounted and the retaining bracket makes a very good electrical ground for the instrument cluster.
