Monitor Engine Temps Accurately

By Larry Klusza, February 2023

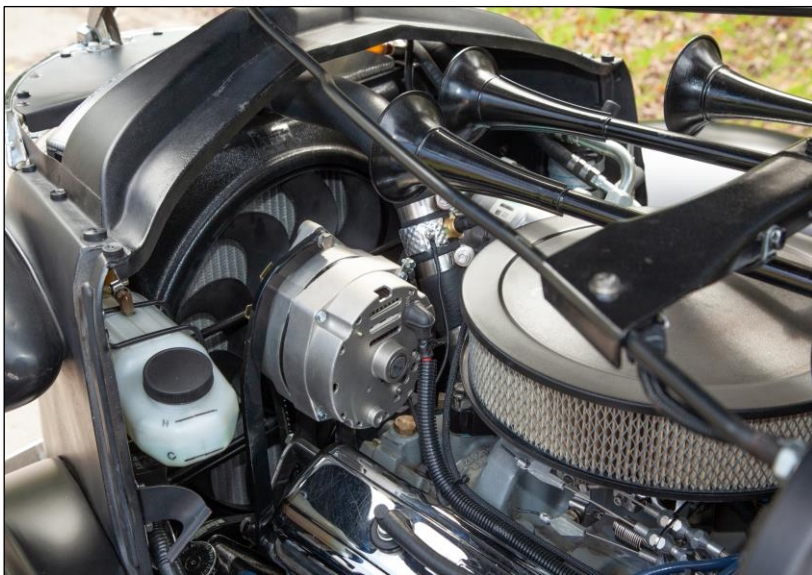
Photo 1: Swapping a small block Chevy V8 for the original 6-cylinder engine makes for a very cramped and hot engine bay.

dedicated cooler, and throttle body fuel injection. The radiator used was a two-row aluminum unit from [PRC Radiators](#), equipped with a 16-pound cap and a catch bottle. The core dimensions measured only 16 x 22 inches, which is not much area at all, so airflow was crucial. It had a [Cooling Components](#) full shroud with a 2500 cfm two-speed electric fan, activated by a [Dakota Digital PAC-2750](#) controller (a newer version, [PAC-2800](#) now adds Bluetooth connectivity). All areas around the radiator were blocked off to force any air entering the cramped nose of the car to go through the radiator. At the time, it was fitted with a Stant™ 180° thermostat. All in all, it was a cramped engine bay! (Photo 1)

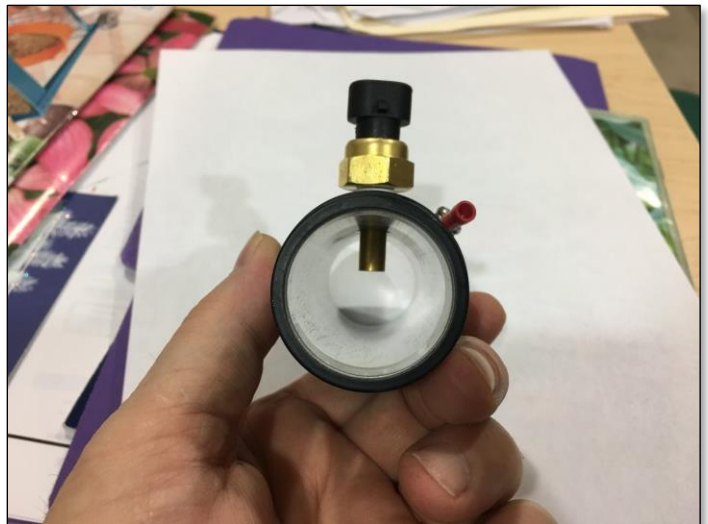
Photo 3: End view showing proper water flow probe placement.

Photo 3: The solution was to relocate the sender to a position in the upper radiator hose where temperatures were confirmed to match what the fuel injection temperature sending unit mounted in the thermostat spacer was reporting. This radiator hose adapter can be found at: [Steiger Performance](https://www.steigerperformance.com/), in the *General Automotive Products* page. Adapters are available with provisions for 1/8" NPT or 3/8" NPT senders.

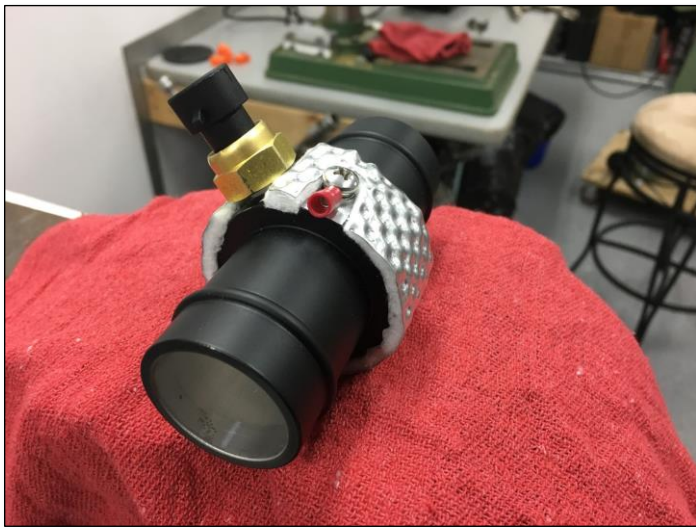
Photo 4: Assembled with insulation on exposed sections as a precaution against potential heat-soak. The connector is for a separate ground.

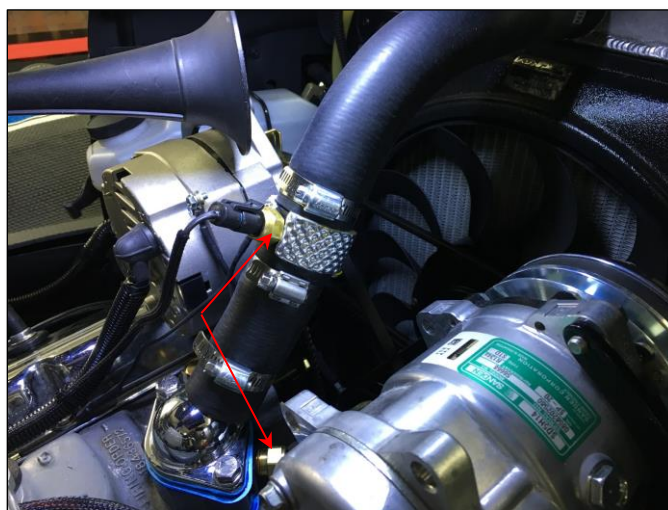
Photo 5: Installation complete. Temp readings at both locations were verified within 2°.

As long as the temperature gauge matched what the fuel injection controller was displaying, it would be fine. When tested, they measured within 2°.

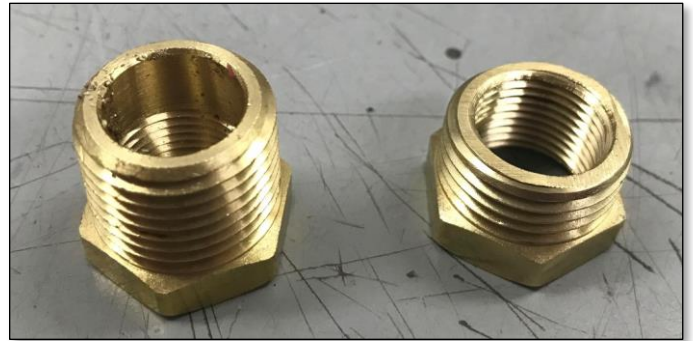
Photo 7: The modified intake manifold adapter: Before (L) and after (R).

(Photo 7) I shortened the adapter to a length of about the distance I measured. I then had to re-tap the intake a bit deeper to take the larger section of threads left on the adapter. I also re-tapped the inside of the adapter to take the sending unit as deep as possible to ensure the probe was fully exposed to coolant flow and as flush as possible on the bottom.

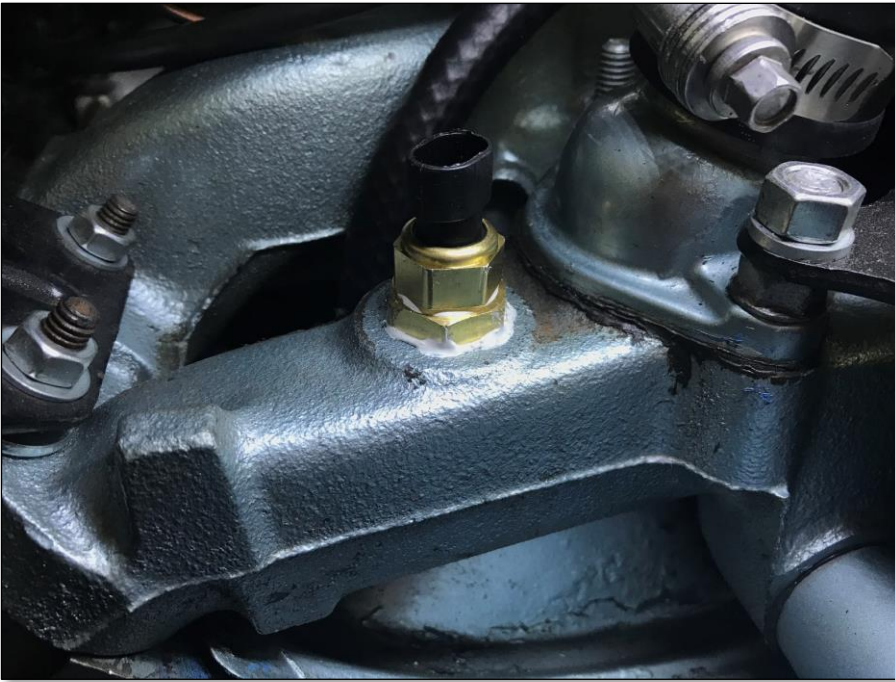
Photo 10 The completed installation.

Photo 10 shows the completed installation. Readings taken with a thermal gun on the upper radiator hose, just beyond the thermostat housing and the factory gauge temp sender matched what the EFI controller was reporting perfectly.
