Steering Column Ignition Lock Fix For GM Overdrive Transmission Conversions

By Larry Klusza, 2023

Disclaimer: What is documented here applies specifically to a 4L60E transmission in a 1970 GTO, but should be applicable to '68-'72 GM A-Bodied cars. Though not guaranteed, it may also serve as a guide for other vehicles as well. I hope you find it helpful. Older cars without a steering column lock are not affected. - L.K.

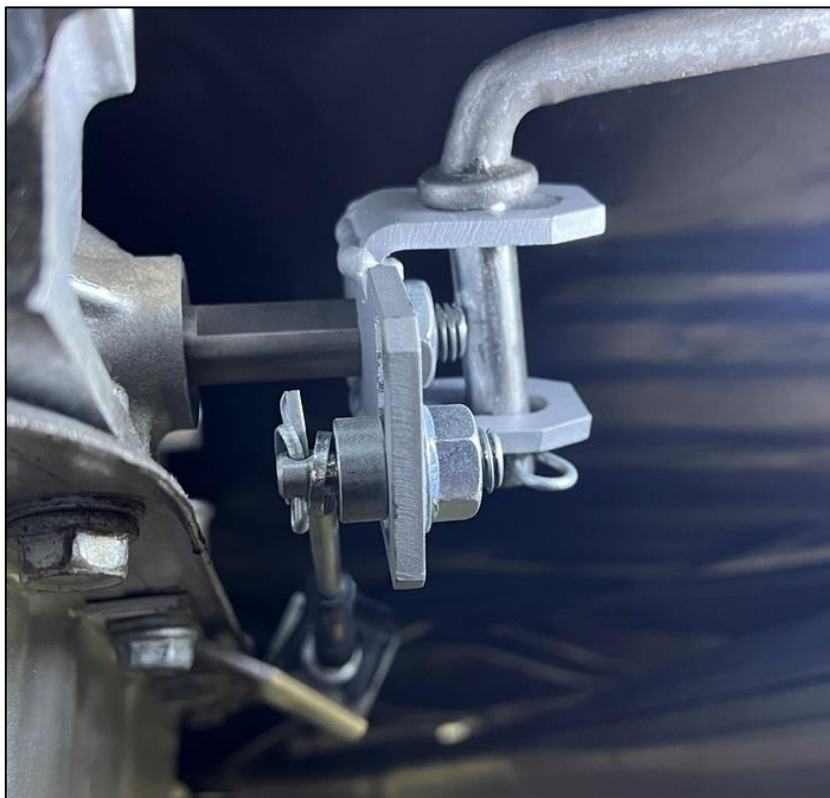
The correct lever for my application was flat, but didn't have the ears. That Shiftworks part number is [4LE-C](#). I removed the ears from the offset bracket and welded them to the new one.

Photo 2: Correct bracket for the 4L60E but modified with "ears" from the old bracket

This resulted in a lever that addressed the shifter cable misalignment and allowed for the retention of the steering column/shifter interlock linkage. A two-for-one solution.

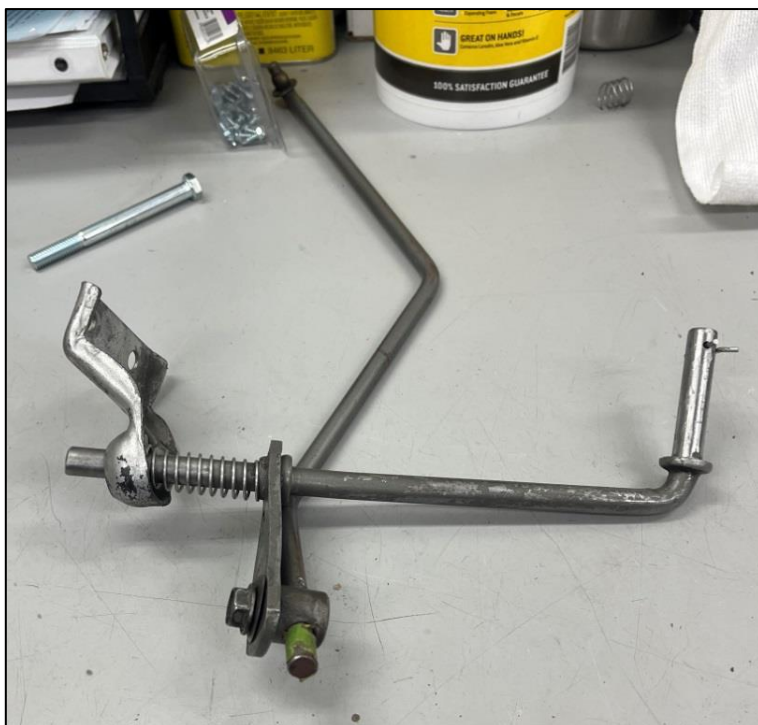
Photo 3 shows the complete stock linkage assembly after removal from the vehicle. Designed for use with a Turbo 350 or 400 transmission, it was barely able to function after the 4L60E was installed.

The longer gear selector shaft on the 4L60E forces the interlock cross shaft deeper into the frame-mounted swivel bracket, to the point of coil bind. Fore/aft misalignment also meant that the vertical rod from the cross shaft up to the steering column was also binding where it connects to the cross shaft.

Photo 3: The Interlock linkage assembly removed from the vehicle.

Basically, the solution for this entailed substituting a 3/8" rod end for the jam screw, wavy spring washer and bushing. The hole size in the cross-shaft tab must be reduced by installing a 5/8" OD by 1/8" thick bushing w/ a 3/8" hole. Nip 2 to 3 coils off the tension spring to avoid coil bind and you're done. Here's how I did mine.

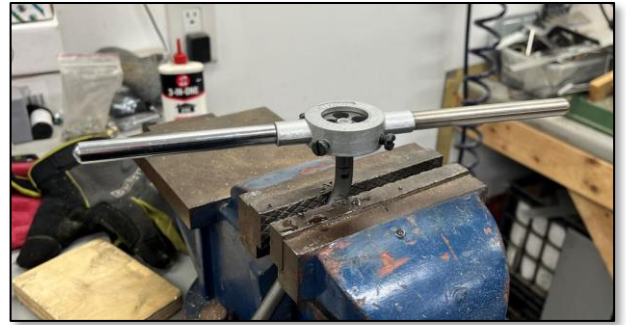
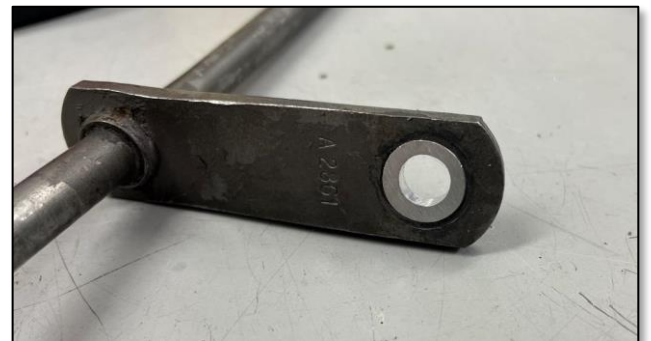
Photo 5

Photo 5: Threading the remaining stub end after the cut

(Photos 4 and 5) First, measure and cut 2.250" from the bottom end of the long rod. Then with a 3/8-24 RH die, thread the balance as far as you can go up to the bend in the rod. This will accommodate the 3/8" rod end.

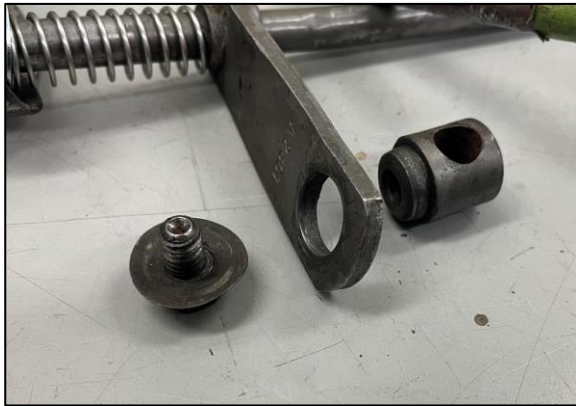
Photo 4

Photo 4: Modifying the lower portion of the steering column rod

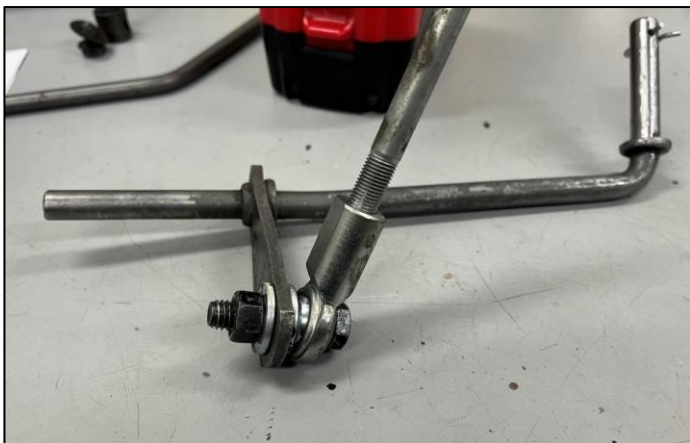
Photo 6

Here is a mockup of the assembly. You can see that the aluminum bushing I made is retained in the pivot tab by a washer on each side, with the bolt holding the whole assembly together. I also put a slight twist in the pivot tab to help things along but am not sure it was truly necessary. Your experience may differ.
